# Periodic Review Report

April 6, 2017 through February 28, 2019  
Hempstead Intersection Street Former MGP Site  
NYSDEC Site #130086

AECOM Project Number: 60411920

March 1, 2019

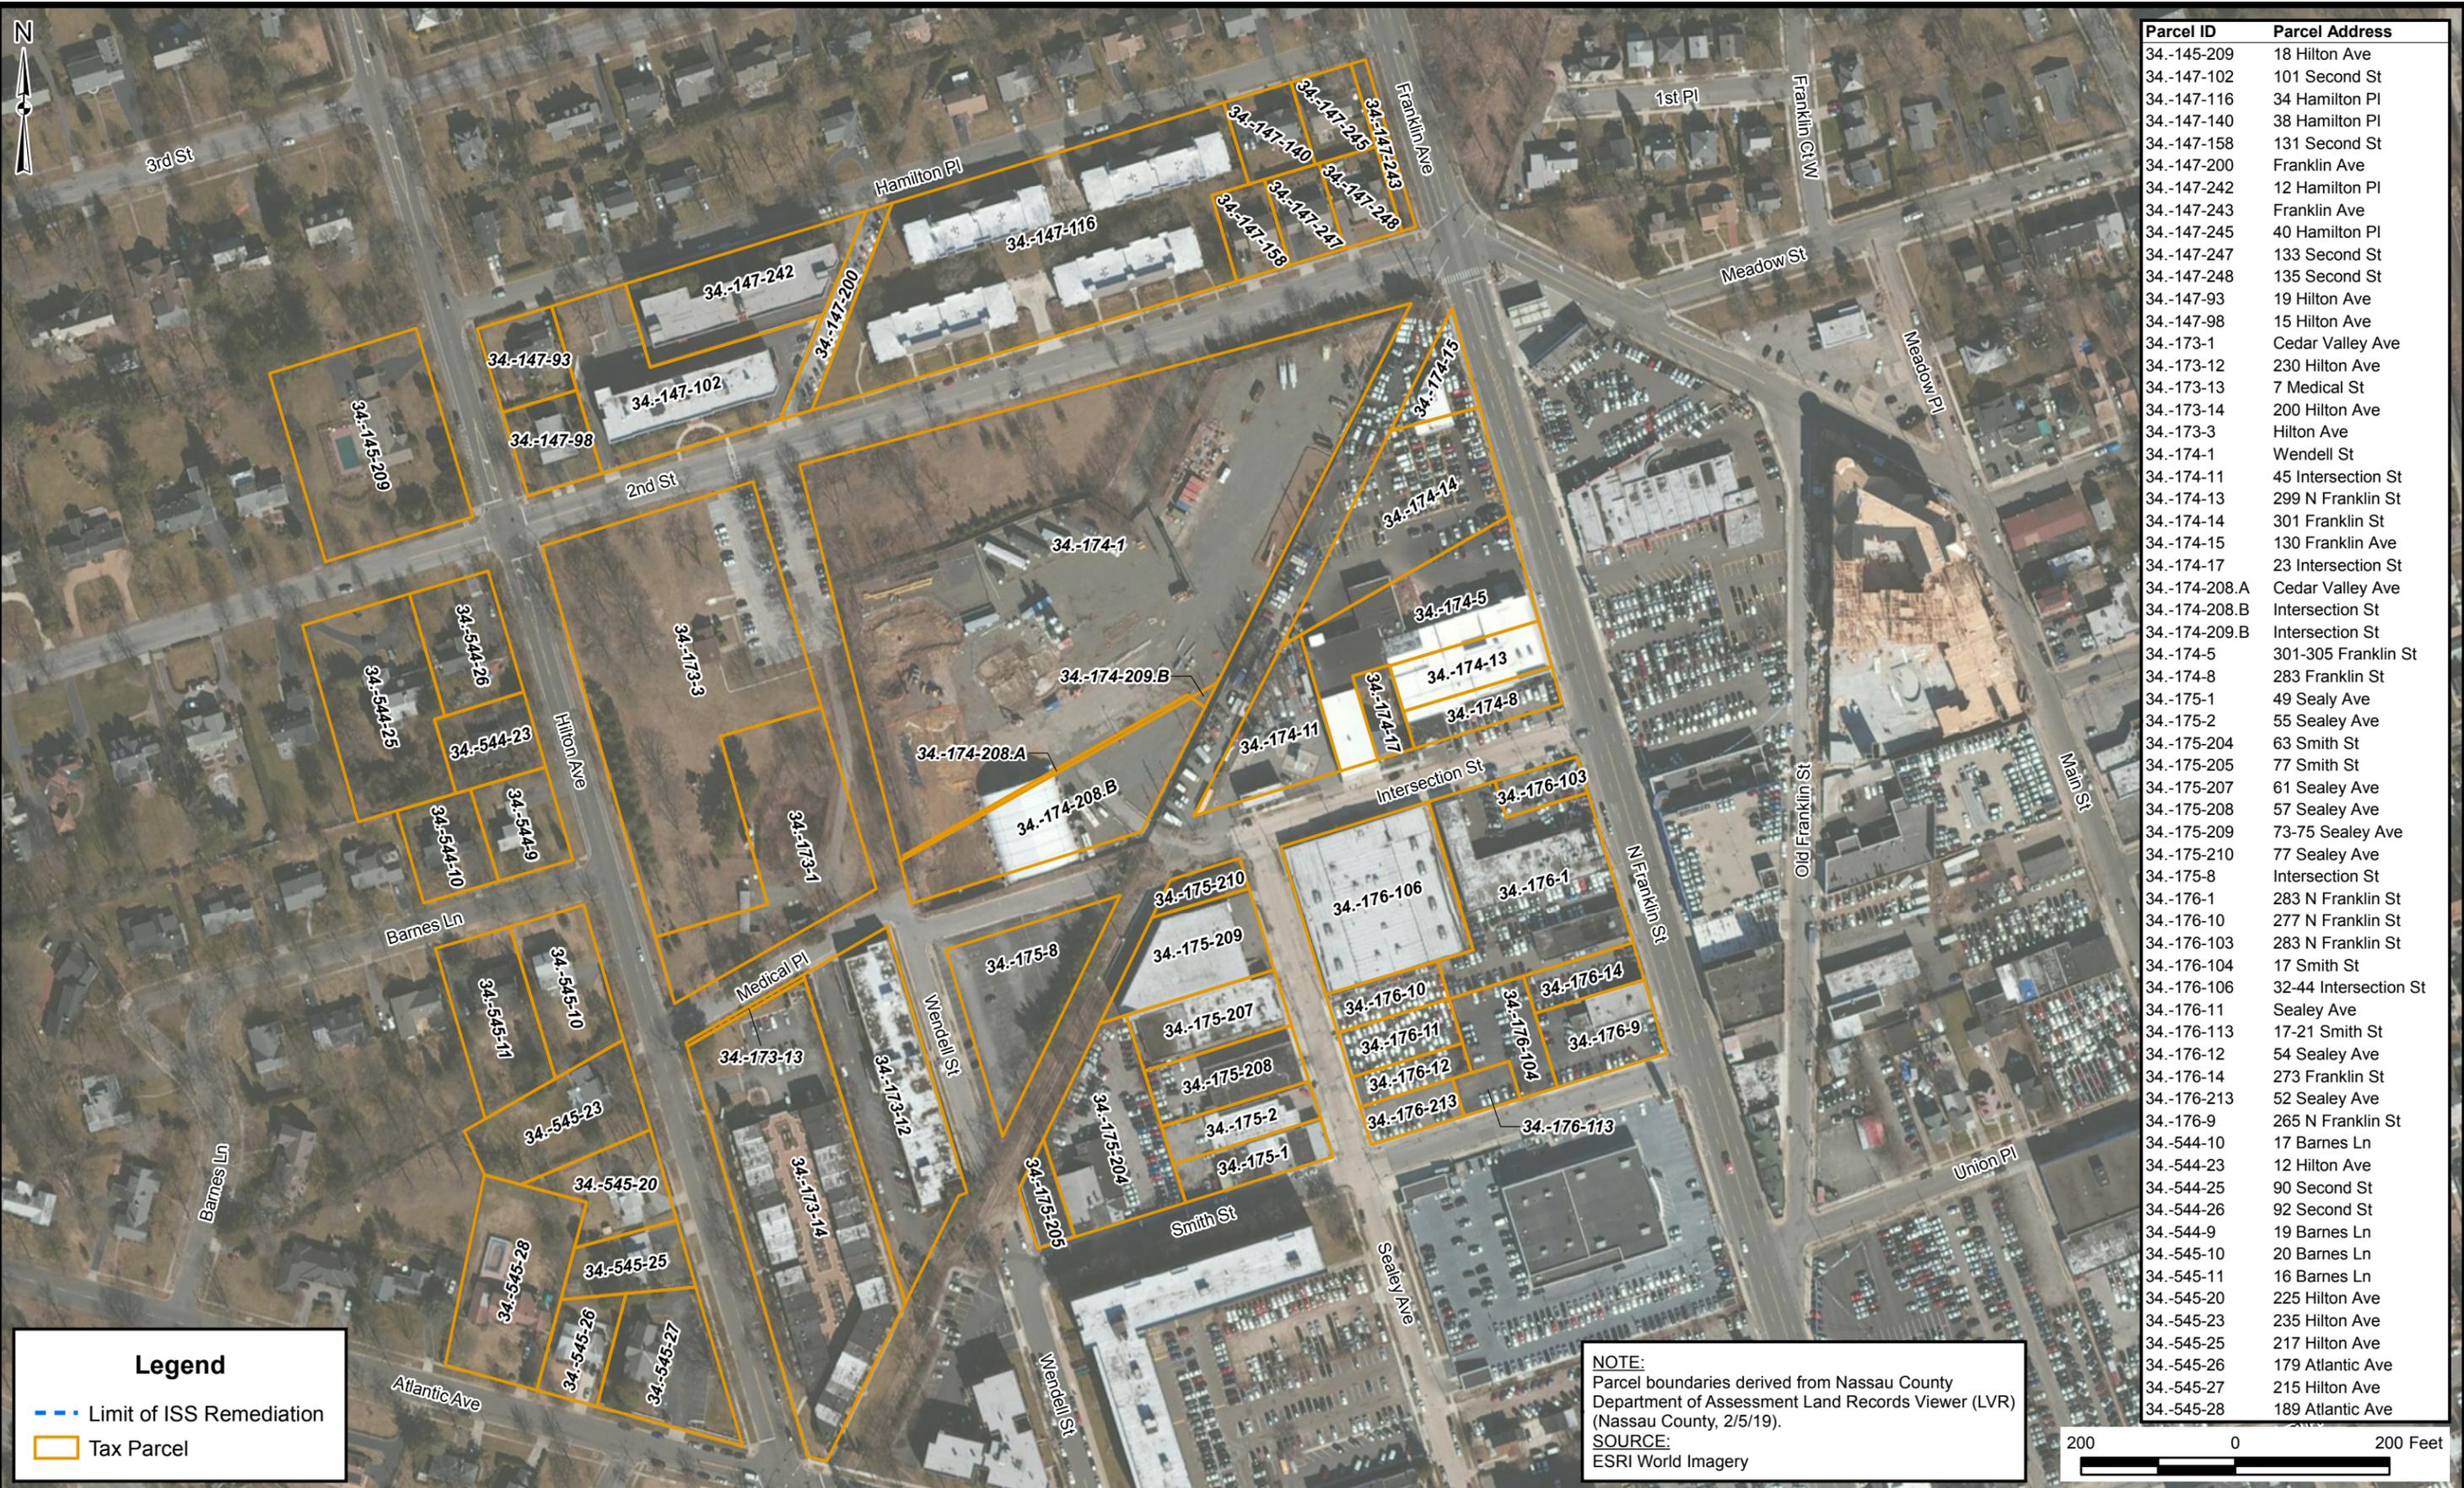
FIGURE 2

These off-Site Areas are shown on Figure 2. Additional off-Site remedial activities include oxygenation systems that address groundwater remediation through oxygen delivery to the subsurface, and the installation and sampling of monitoring wells located throughout the neighborhood.

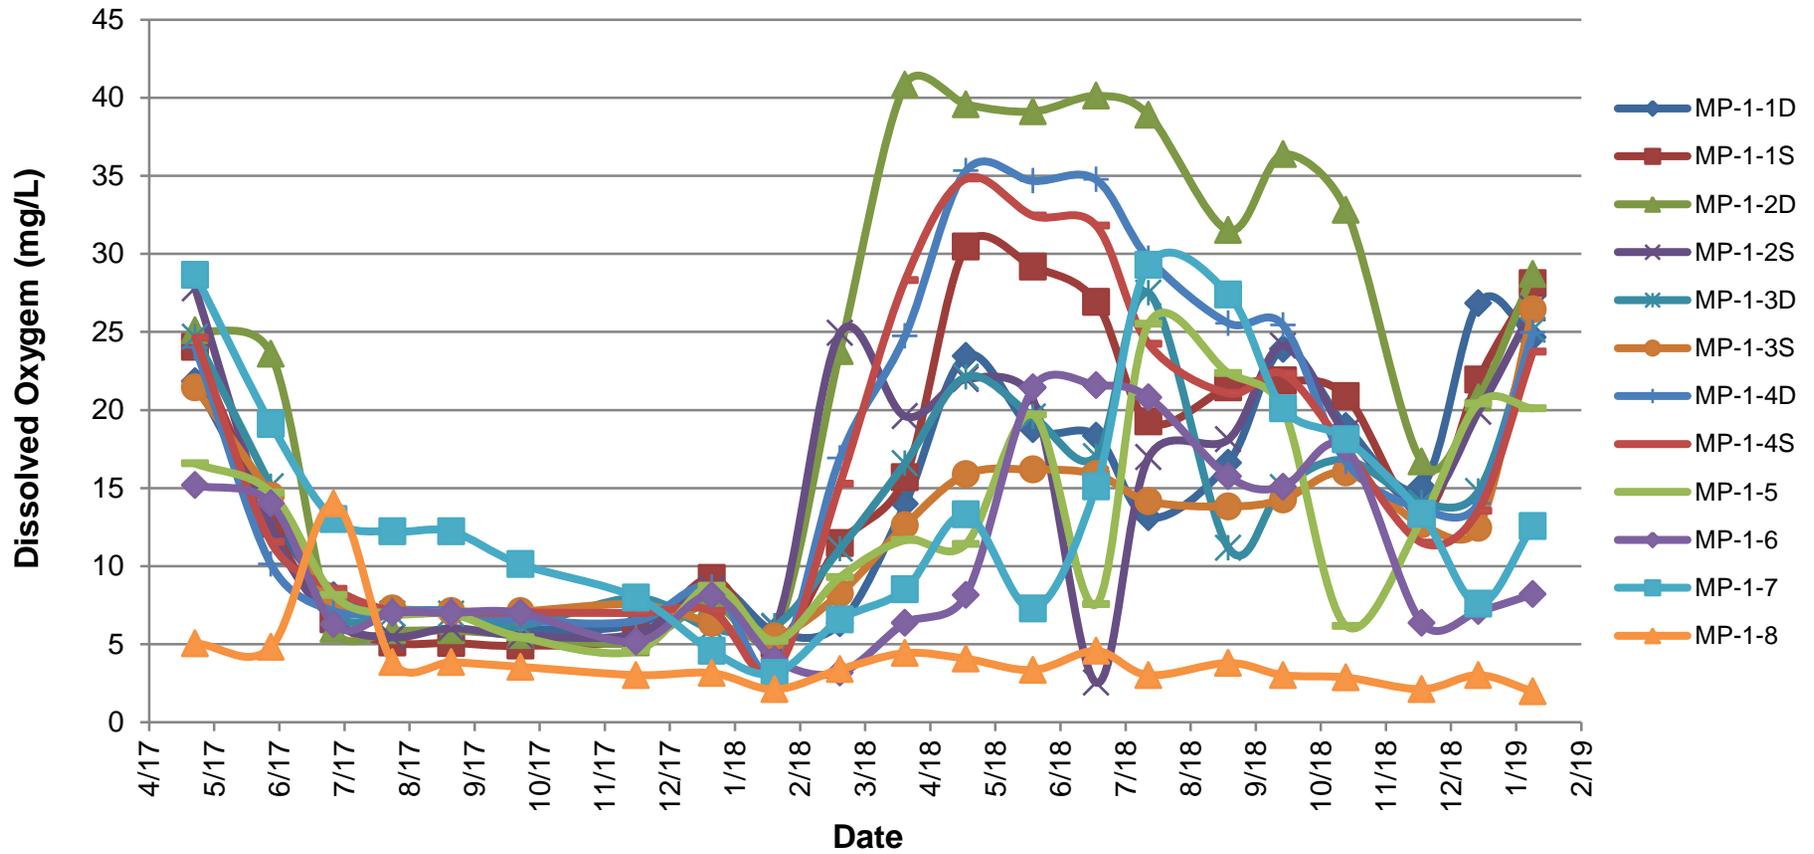
Figure 17  
Oxygen System #1  
Dissolved Oxygen Concentrations

Figure 17 shows that during the time System #1 was down for repairs, oxygen concentrations dropped to a range of 3 to 12 milligrams per liter (mg/L) (most measurements were between 5 and 10 mg/L). Although this is considerably below the higher levels achievable by the oxygen delivery technology, these levels represent concentrations that would be in equilibrium with sparged air (containing 19% oxygen) and thus still represent aerobic conditions. However, as discussed below in Section 6.2, BTEX and PAH concentrations increased during this period in two wells immediately downgradient of this system, but decreased to non-detect once System #1 resumed normal operation.

Note: In June 2017, the compressor on Oxygen System #1 failed; replacement compressor was not installed until January 2018.

During the reporting period, System #2 operated continuously, but System #1 did not operate for approximately seven months as a series of repairs were required. In June 2017, the System #1 compressor started overheating triggering system shutdowns. Temporary repairs were performed in early June by National Grid's O&M contractor, IP&T, but they were not effective as the system shut down again later that month. IP&T then requested to procure an electric motor subcontractor D&D Electric Motors to visit the Site to troubleshoot and repair. Troubleshooting by D&D Electric Motors during July 2017 did not fix the system.

National Grid then authorized IP&T to retain the compressor manufacturer's (Kaeser) service company for the diagnosis of necessary repairs. Kaeser was not able to schedule a site visit until October 2017, at which time they identified and recommended repairs and provided National Grid with a cost estimate. As required for compliance with internal and regulatory management requirements, National Grid requested a price quotation for replacement of the compressor as an alternative to repairs, which was provided in November 2017. Because the cost for replacement was considerably more expensive, National Grid opted to repair the compressor. Due to the lead time required for procurement of replacement parts, repairs did not commence until December 4, 2017. While these repairs successfully fixed the motor overheating problem, a new problem related to pressure control was discovered. At that point, National Grid abandoned continued attempts to repair the compressor and opted to replace the entire unit. The replacement compressor was installed in January 2018. Upon installation and start-up of the new compressor, damage was found in the load center, which required additional repair. These repairs were performed in February 2018, and the system has been running continuously since then.

The two oxygenation systems remain effective in maintaining high oxygen concentrations in the groundwater. Oxygen concentrations downgradient of System #1 returned to the previous high levels soon after the system was restarted following repairs. However, the downtime for System #1 allowed BTEX and PAH concentrations to increase for a short period of time in wells HIMW-20I and HIMW-25.

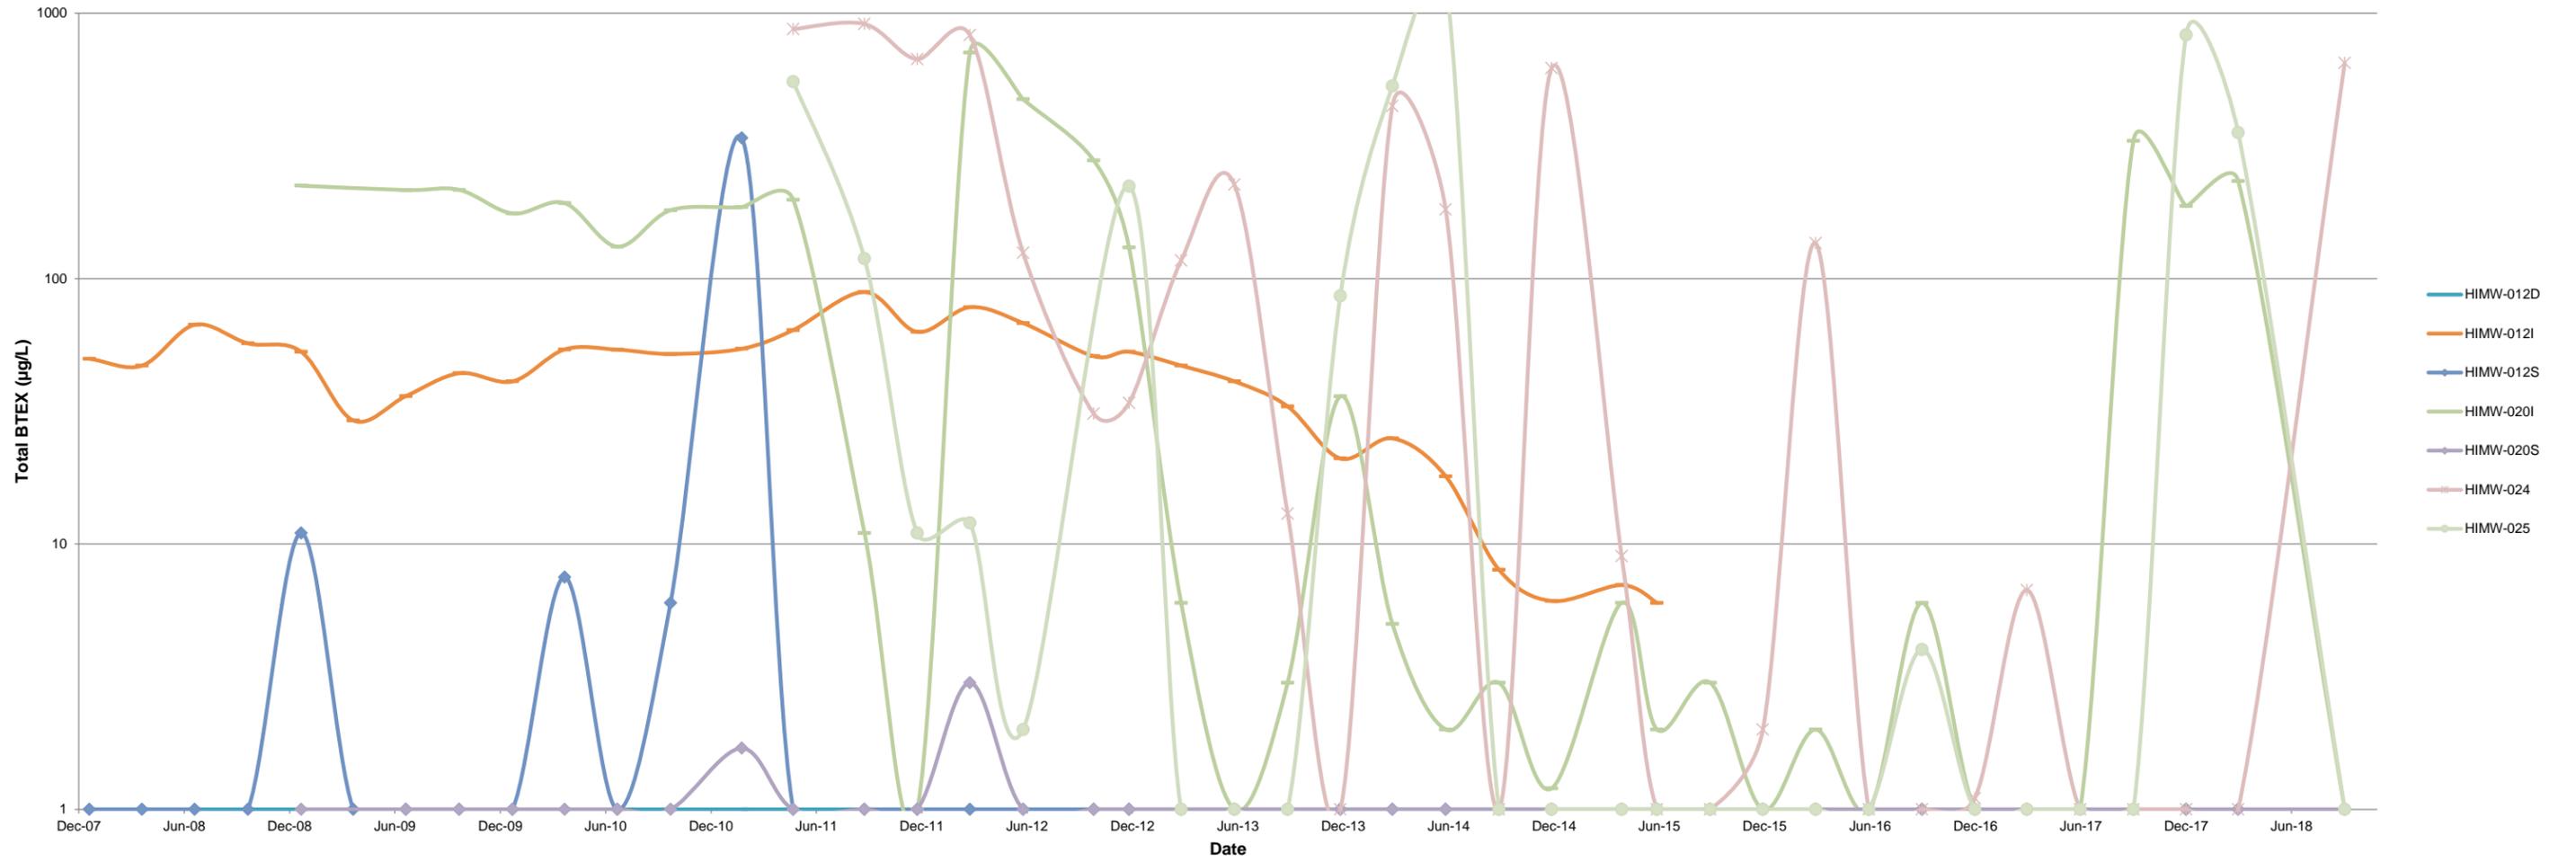
Figure 19A  
Total BTEX Concentrations in Wells  
Downgradient from Oxygen System #1 and Upgradient from Oxygen System #2

breakdown, conditions within the aquifer remained aerobic throughout the period, allowing for continued biodegradation of dissolved hydrocarbons, although contaminant increases were observed in two wells (HIMW-20I and HIMW-25). In September 2018, BTEX and PAHs levels returned to non-detect in these wells, showing returned effectiveness of System #1.

The oxygen delivery systems have been effective in reducing the size and concentration of the downgradient plume. In contrast to the current plume extent shown in Figures 5 through 9, the plume as it existed at the time the oxygen delivery systems were started is shown on Figure 14. Figures 19 and 20 show the total BTEX and PAH concentrations (respectively) in all wells monitoring the plume downgradient of System #1. These charts use a logarithmic concentration scale to effectively show the wide range of concentrations observed in these wells. For the purposes of data presentation, non-detects are shown as a concentration of 1 µg/L. These charts show that following the startup of the systems in 2011, there has been a clear decreasing trend in these wells. This trend is especially clear in the further downgradient wells HIMW-13I and D, HIMW-14I, and HIMW-15I (of the three wells in each of the “13”, “14”, and “15” clusters at these three locations, these are the ones whose screens intercepted the plume). This trend is more evident with BTEX than with PAHs. It is unclear why well HIMW-24, installed upon completion of the oxygenation systems construction, exhibits wide swings in concentration, but this well has had very low contaminant concentrations during the three of the last four monitoring events. As stated above, concentrations in two wells (HIMW-20I and HIMW-25) immediately downgradient of System #1, increased in concentration during the period when System #1 was undergoing repairs, but decreased to non-detect in September 2018.

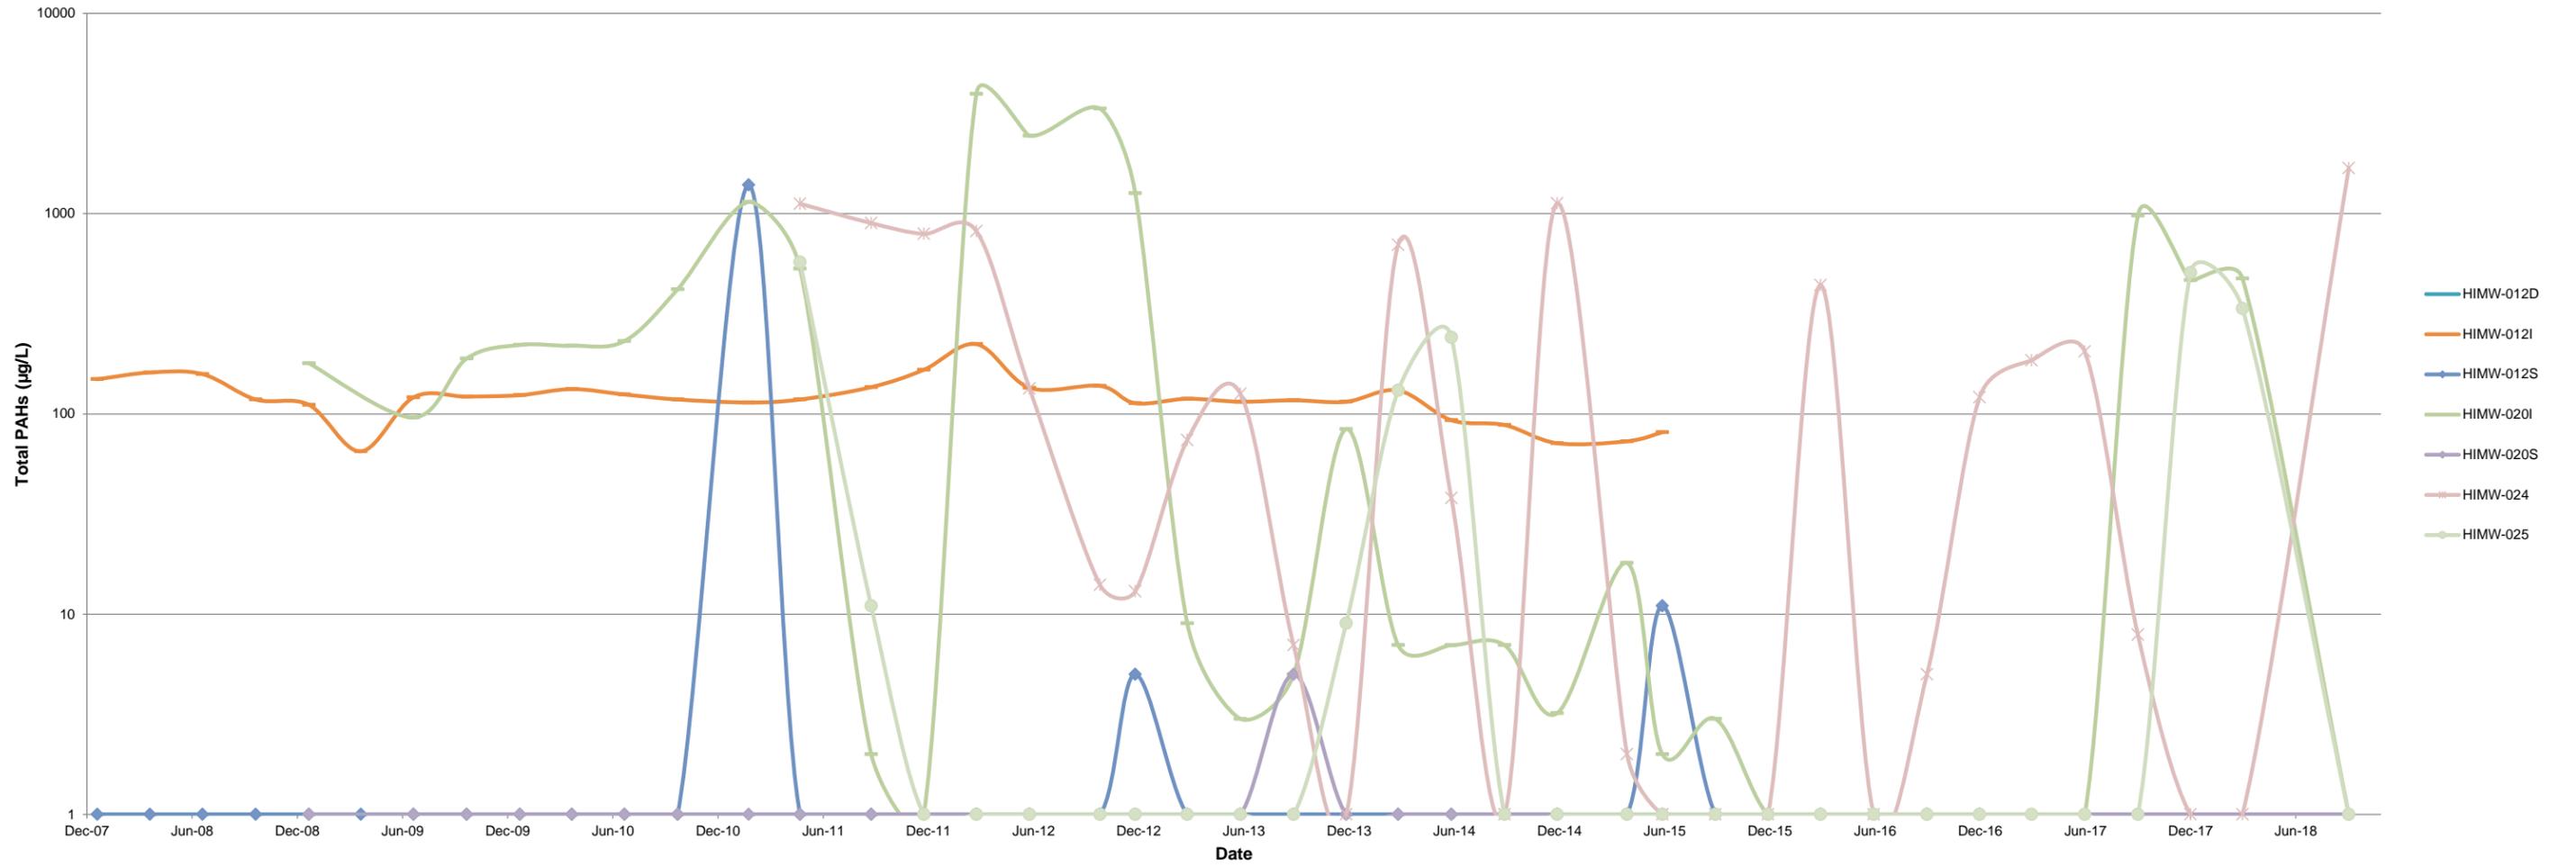
Figure 20A  
Total PAH Concentrations in Wells  
Downgradient from Oxygen System #1 and Upgradient from Oxygen System #2

The plume changed slightly during this reporting period. Likely due to the repairs required for Oxygen System #1, which kept the system offline from June 2017 until January 2018, both BTEX and PAH levels increased during the shutdown in wells HIMW-20I and HIMW-25 (immediately downgradient of the oxygen delivery lines), but returned to non-detectable in September 2018. Elevated PAH levels observed prior to this reporting period in well HIMW-24 continued into the first sampling event of this reporting period (June 2017) then decreased until September 2018, when an increase in PAH and BTEX levels was observed. This increase may represent a delayed response as groundwater that passed through the vicinity of Oxygen System #1 during the maintenance shutdown subsequently reached HIMW-24.
