**Periodic Review Report  
March 28, 2021 – March 28, 2022  
Hempstead Intersection Street  
Former MGP Site**

Town of Hempstead, Nassau County, New York  
Site ID #1-30-086

April 2022  
Project: 1905774

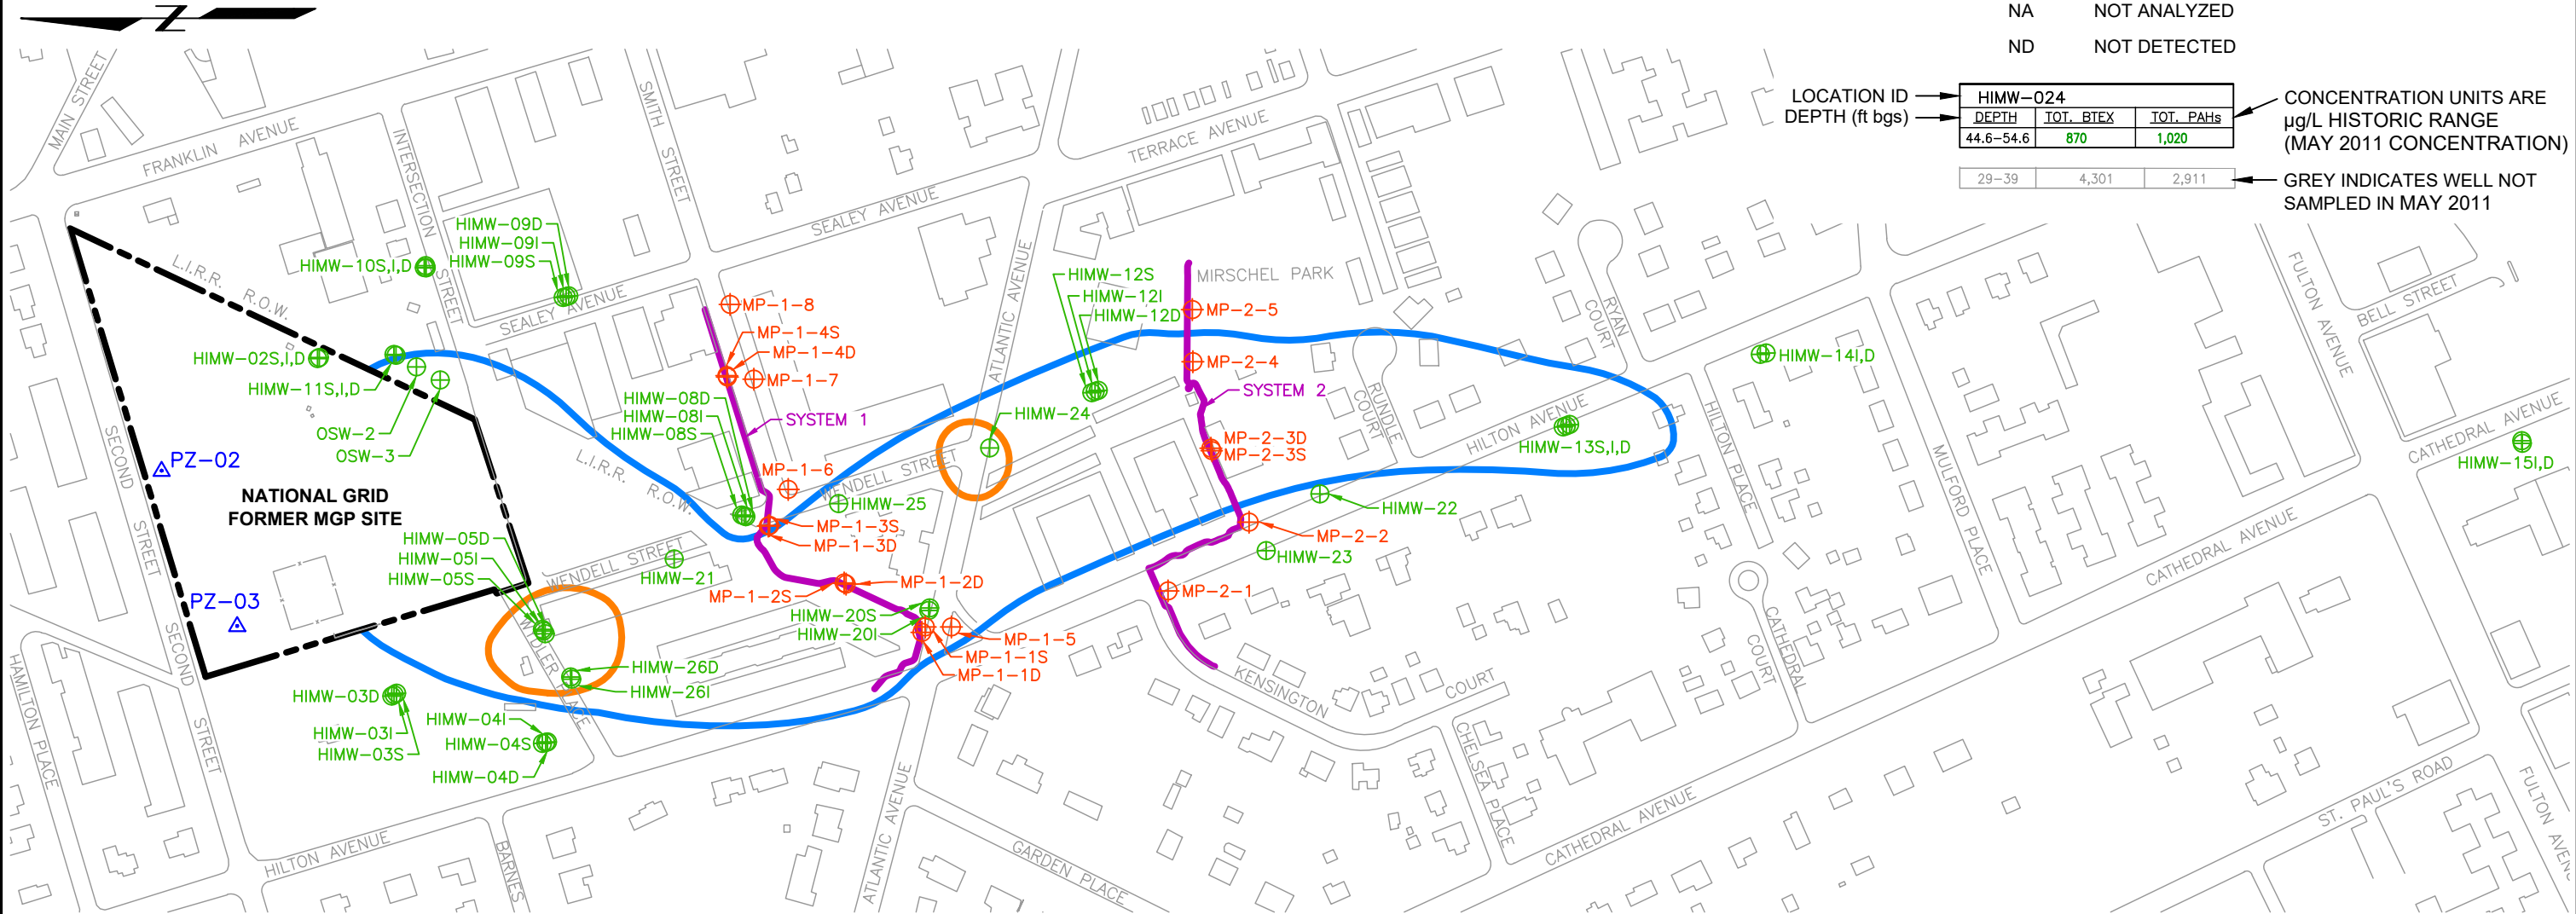
| | | Project 1905774    April 2022    Fig. 15 |

**SOURCE:**  
FIGURE BASED ON FIGURE 14: EXTENT OF DISSOLVED-PHASE PLUME AND GROUNDWATER ANALYTICAL RESULTS - MAY 2011, HEMPSTEAD INTERSECTION STREET FORMER MGP SITE, PREPARED BY AECOM, SCALE: 1" = 300', DATE: 2/22/19.

| Periodic Review Report<br>Hempstead Intersection Street Former MGP<br>Hempstead/Garden City, New York<br> | | EXTENT OF DISSOLVED-PHASE<br>PLUME AND GROUNDWATER<br>ANALYTICAL RESULTS -<br>MAY 2011 |
